POWER PLANT AND
DRIVE TRAIN IMPROVEMENTS
OF THE
NPS HUMMINGBIRD
REMOTELY PILOTED HELICOPTER

Robert E. Conway

September, 1996

MASTER OF SCIENCE IN AERONAUTICAL ENGINEERING

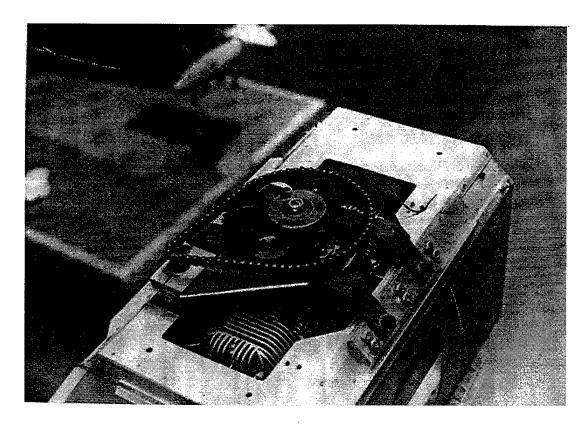
Figure 1. Original Starting System Configuration

The starter motor was found to be under powered. Prior starting attempts required two fully charged 12 volt marine batteries connected in series (24 volts total) for the electric motor to provide enough starting torque to the engine. This configuration ran the risk of burning out the starter motor and causing an electrical fire on the airframe.

Removal of the power cables risked entanglement of the cables in the main rotor system as the cables were free to whip as they were pulled from the fuselage. The main rotor arc extends 5 feet from the rotor hub and sits approximately 3 feet off the ground. Entanglement of the cables is an unnecessary risk to the program and a safety hazard.

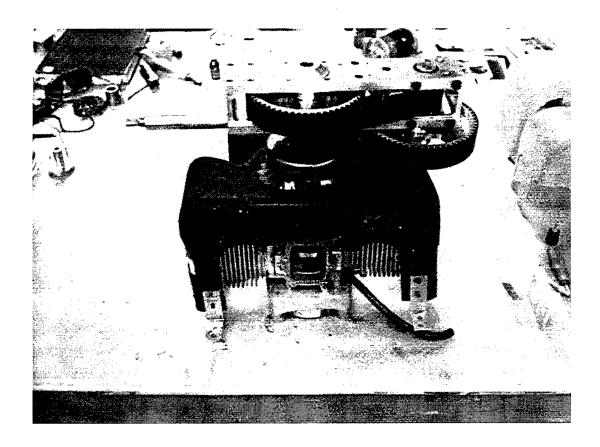
Figure 2. Layout of Engine Cooling Components

The original design of the *Hummingbird*'s engine-cooling system was proven inadequate by failure of the engine due to overheating. The engine manual states that the maximum cylinder head temperature measured at the spark plug gasket is not to exceed 482° F and maximum exhaust gas temperature is not to exceed 1022° F. Upon inspection of the

failed engine, deep scoring was found in both cylinders. The pistons were locked into the cylinders and unable to be removed. Deposits of metal were also found fused to the cylinder walls pointing to a massive overtemp of the engine.

The "cooling air-flow" was insufficient for the following reasons. First the cooling system was designed to draw air in to the center of the engine and then to direct it out along the cylinder. The cooling fins were perpendicular to the direction of flow causing the airflow to be disrupted as it moved further away from the center of the engine. Sufficient airflow to the cylinder head was therefore not available. A significant amount of the fiberglass cowling that directed the airflow over the engine had also been trimmed away to accommodate the starter and exhaust components. In order to mount the starter an approximately 3x5 inch square had to be removed. Other cut-outs for the engine exhaust, decompressors (small ports mounted on both cylinder barrels to aid in engine ignition) and mounting hardware, shown in Figure 3, had widdled away at the intended design rendering this component ineffective.

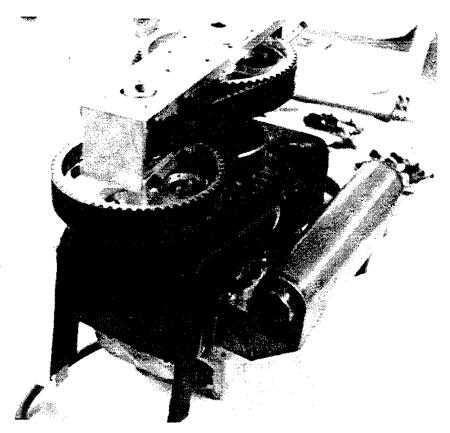
Figure 4. Exhaust Manifold Position

The exhaust manifold was also positioned just 2 inches from the intake of the cooling fan as seen in figure 4.

The result was an intake of cooling air with an equal or higher temperature than the maximum cylinder head temperature.

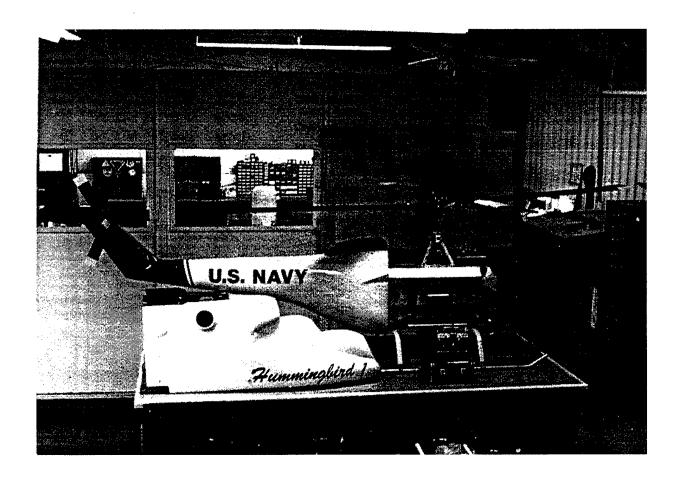
Figure 5. Right Side View of *Hummingbird* Without Ventilation Port body shell and the exhaust manifold's position just inside the fuselage. The solid fiberglass shell on right side allowed a build up of the exhaust manifold temperature which could have further increased the cooling air temperature at the intake of the cooling fan. The object seen in the hole in the fuselage in Figure 6 is the exhaust manifold.

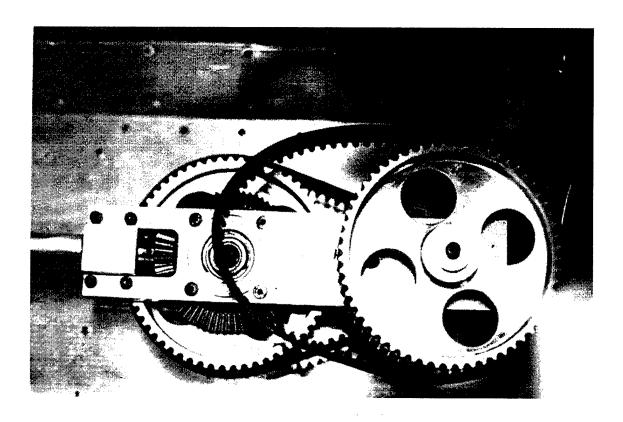
Figure 6. Main Transmission

As mentioned in the background investigation chapter, massive torque fluctuations due to unsteady idle speeds exist. These torque fluctuations were reported to, however unverified, snap the main rotor shaft of a similar RPH. In any case, fluctuations in engine torque are magnified ten times at the main rotor shaft due to the 10:1 mechanical advantage given by the transmission. With the exception of the hard rubber belts and limited slipping in the centrifugal coupling, there is nothing to absorb any sort of shock caused by torque

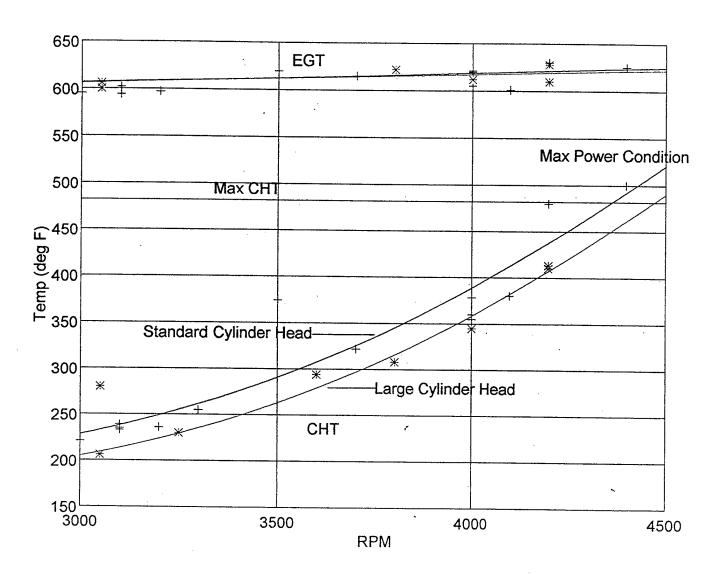
Figure 10. CHT Comparison for Large and Small Cylinder Heads

Runs at maximum throttle showed a maximum CHT of 435°F. The effect of the increased

area of the cylinder head reduced the maximum CHT by over 47°F in static conditions. A comparison of the EGT and CHT observed with the two sizes of cylinder heads is shown in Figure 10.

This determination moved the cooling system design away from a high mass flow system to an interior ventilation or low mass flow system in which the induced air flow velocities over the engine on the test stand would be matched or increased inside the fuselage.

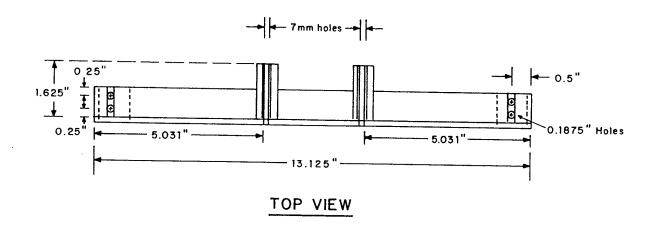
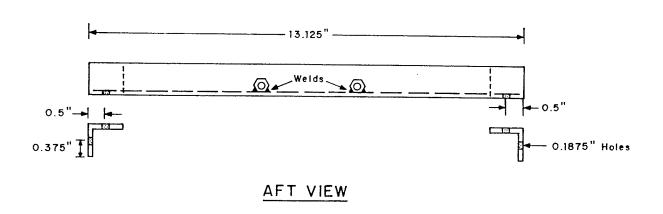
Figure 16. Upper Engine Mount

The bracket modification led to another problem. The upper engine mount braced the engine through two of the six 6 mm cylinder head bolts. There existing cylinder head bolt was not long enough to provide support for the cylinder head and also pass through the upper engine mount. Attempts to find longer bolts and 6mm threaded rod failed as no local supplier carried the longer bolts or metric size threaded rod. As a result, two adapters which acted as a cylinder head bolt, spacer and upper engine mount attachment point were designed to custom fit this application. Figure 17 shows this piece. The cylinder head bolt segment is 6 mm in diameter and includes the correct cylinder head bolt thread length. The spacer was designed to provide a gap between the cylinder head and upper mount brace so there will be no damage inflicted on the cylinder head heat fins while the both the engine and airframe vibrate. The remainder consists of the mounting bracket threads which are also 6 mm in diameter.

(1) Upper Engine Mount. As the engine required some minor modification on the test stand, the *Hummingbird* required some airframe modification to accommodate the new enlarged cylinder heads. The four engine mounting points on the bottom of the airframe remained unchanged; however, the upper engine mounting bracket that was installed as a part of LT Greg Fick's [ref. 3] modifications shown in Figure 16 had to be moved aft by at least 1.04 inches due to the difference in the cylinder head thicknesses. The two side stiffening plates were moved aft to provide the necessary airframe support for the bracket's new position.

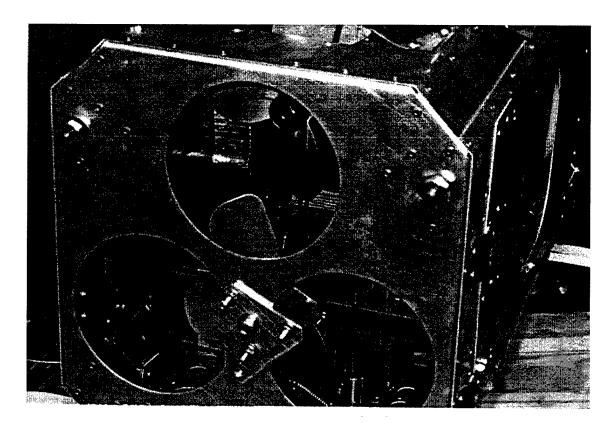
Figure 18. Cooling Fan and Drive Configuration

Information on this fan was unavailable. Measurement of the cooling fan air flow at 1500 rpm (approximate fan rpm at engine idle) showed approximately 345 cfm.

performance charts, the air flow at 2800 rpm is estimated at 480 cfm. Thus the two fans together produce 960 cfm at 7000 engine rpm through the engine compartment which exceeds the air flow pattern seen on the engine test stand.

After considering many options of cooling fans, configurations and suggestions from industry, a simple and reliable design was implemented. The cooling air velocity through the engine compartment was observed during the engine tests and a system to move air through at this speed was introduced. Two air-conditioning condenser fans rated at 500 cfm at 3000 rpm were purchased for less than \$6.00 and mounted to ventilate the new 1.3 cubic foot engine compartment. One fan was modified to fit on the tail rotor drive take-off shaft off the main transmission which rotates at 40 percent of the engine rpm or 1200 to 2800 rpm. The other fan was mounted to the rear wall of the engine compartment. As shown in Figure 20, the lower fan is driven by a belt drive configuration and rotates at the same rpm as the tail rotor drive shaft. The tail rotor shaft mounted fan provides cooling air primarily to the forward cylinder while the belt driven fan provides ventilation to the aft cylinder.

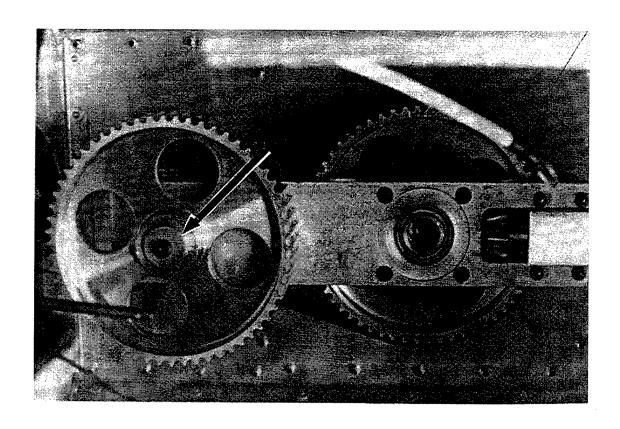
Figure 19. Intermediate Shaft of the Main Transmission

The foretold and observed torque fluctuations of the engine were measured at a maximum of 10 ft-lb. Ideally the location in which to dampen the shock would be at the point of the maximum moment which in this case is the main rotor shaft. However, there is no room for any addition to this space due to the main rotor control rods and other connections. Balancing available space and shock reduction requirements placed the shock absorber design location at the intermediate shaft where the transmission picks up the engine drive. At this point the mechanical advantage is 3.2:1 putting the torque impulses at ±32 ft-lbs. A shock absorber must be able to withstand and dampen this shock moment in addition to a maximum constant driving torque of 77 ft-lbs (24 ft-lbs from engine) at the intermediate shaft.

The intermediate shaft on the transmission shown in Figure 19 was selected as the location for the shock absorber assembly. The shock absorber itself is a Metalastik®

Rotoflex® coupling. It consists of a hexagon of rubber with six metal inserts bonded into position. It also contains metal interleaves bonded into the rubber for increased torque capacity when required. The coupling must be able to withstand a 76.8 ft-lb sustained load plus a 32 ft-lb impulse load totaling a maximum load of 108.8 ft-lbs. The 76.8 ft-lb moment was obtained by using the maximum torque rating of 24 ft-lbs and multiplied by 3.2 for the load at the intermediate shaft. A coupling closest to this specification was ordered. This size coupling gives a safety margin of 1.33 computed for rated maximum torque to estimated
